# **DRAFT ENVIRONMENTAL IMPACT REPORT**

### **SECTION 24G APPLICATION TO RECTIFY THE UNLAWFUL COMMENCEMENT OR CONTINUATION OF LISTED ACTIVITIES IN TERMS OF SECTION 24G OF THE NATIONAL ENVIRONMENTAL MANAGEMENT ACT (NO. 107 OF 1998)**

### **LOCATED ON HOLDINGS 105 AND 106 OF BLUE HILLS AGRICULTURAL HOLDINGS UNDER THE JURISDICTION OF THE CITY OF JOHANNESBURG METROPOLITAN MUNICIPALITY**

| DOCUMENT STATUS | |
|---|---|
| <b>Document Name</b> | S24G Environmental Impact Report |

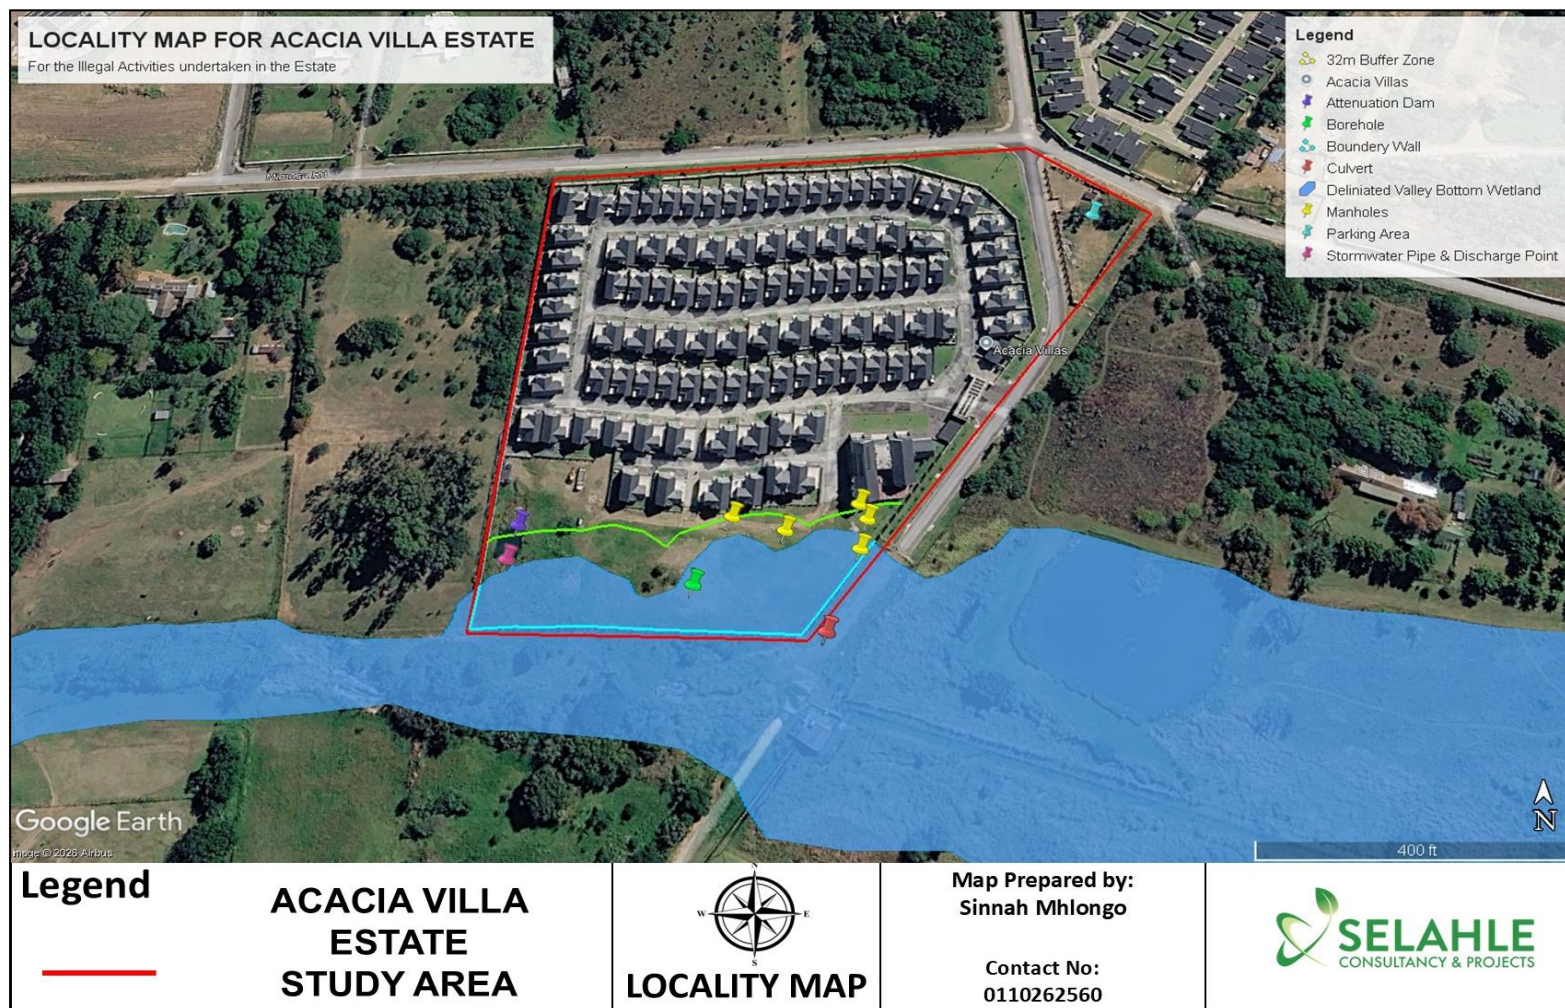
Figure 1: Locality Map for showing the Illegal Activities

| <b>Unlawful Activities</b> | <b>Coordinates</b> |
|---|---|
| The construction of a culvert within the buffer area, | <b>25°57'34.96"S 28° 5'25.09"E</b> |
| and development of a parking area within Critical Biodiversity Areas (CBAs) and Ecological Support Areas (ESAs). | <b>25°57'27.82"S 28°5'29.69"E</b> |

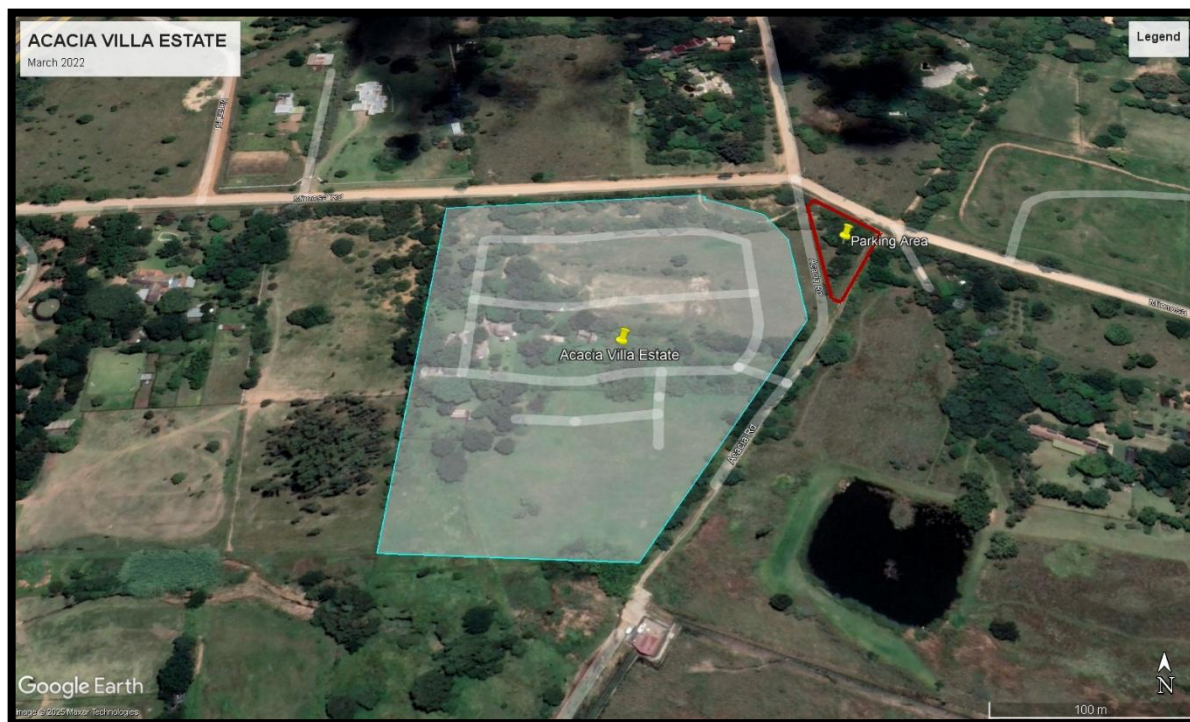
Figure 3: Google Earth image of the site in March 2022 prior to development

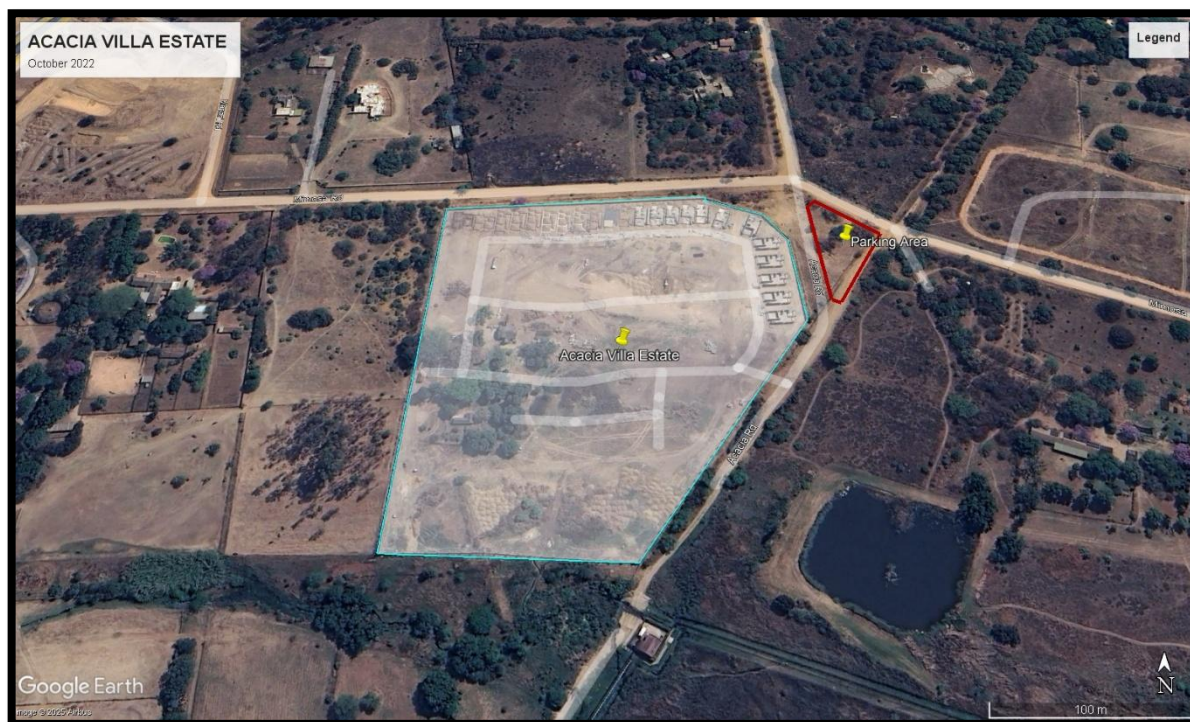
Figure 4: Google Earth image of the site in October 2022 during the commencement of construction activities

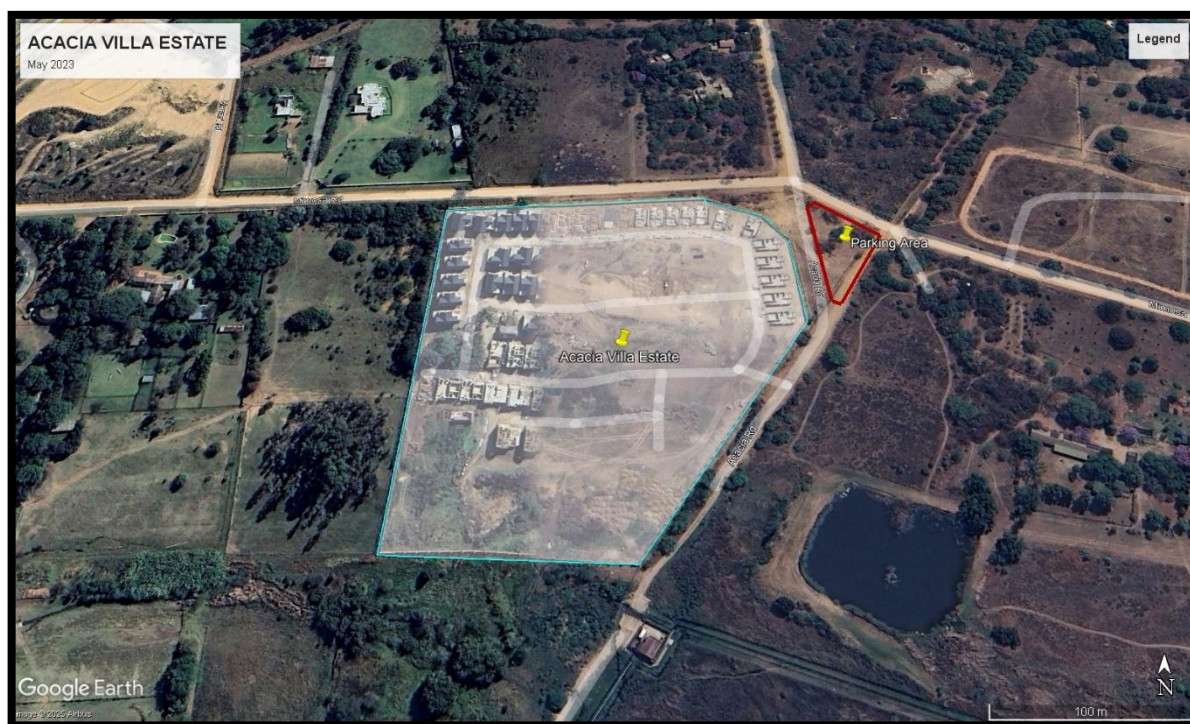
Figure 5: Google Earth image of the site in May 2023 – as construction progresses

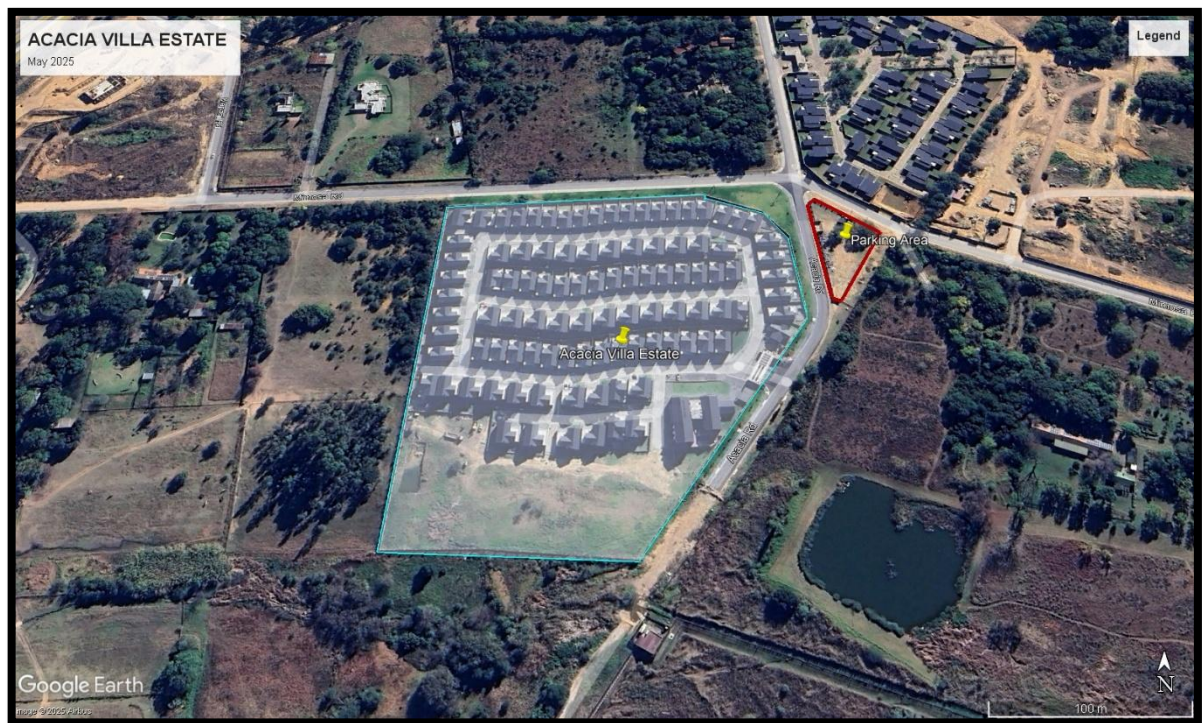
Figure 7: Google Earth image of the site in May 2025 – during the operation of the Estate
