**GEOHYDROLOGICAL INVESTIGATION STUDY FOR THE DEVELOPMENT OF  
ACACIA VILLAS LOCATED IN MIDRAND WITHIN CITY OF JOHANNESBURG  
METROPOLITAN MUNICIPALITY OF GAUTENG PROVINCE IN SOUTH AFRICA.**

**REPORT STATUS: FINAL REPORT (REVISED VOL01)**

**DATE: 26 JUNE 2026**

**Project No.:** AC-HG-01/04Revised  
**Project Team:** FL Makhuvha, Hydrogeologist (Pri.Nat.Sci./MGSSA/GWD)

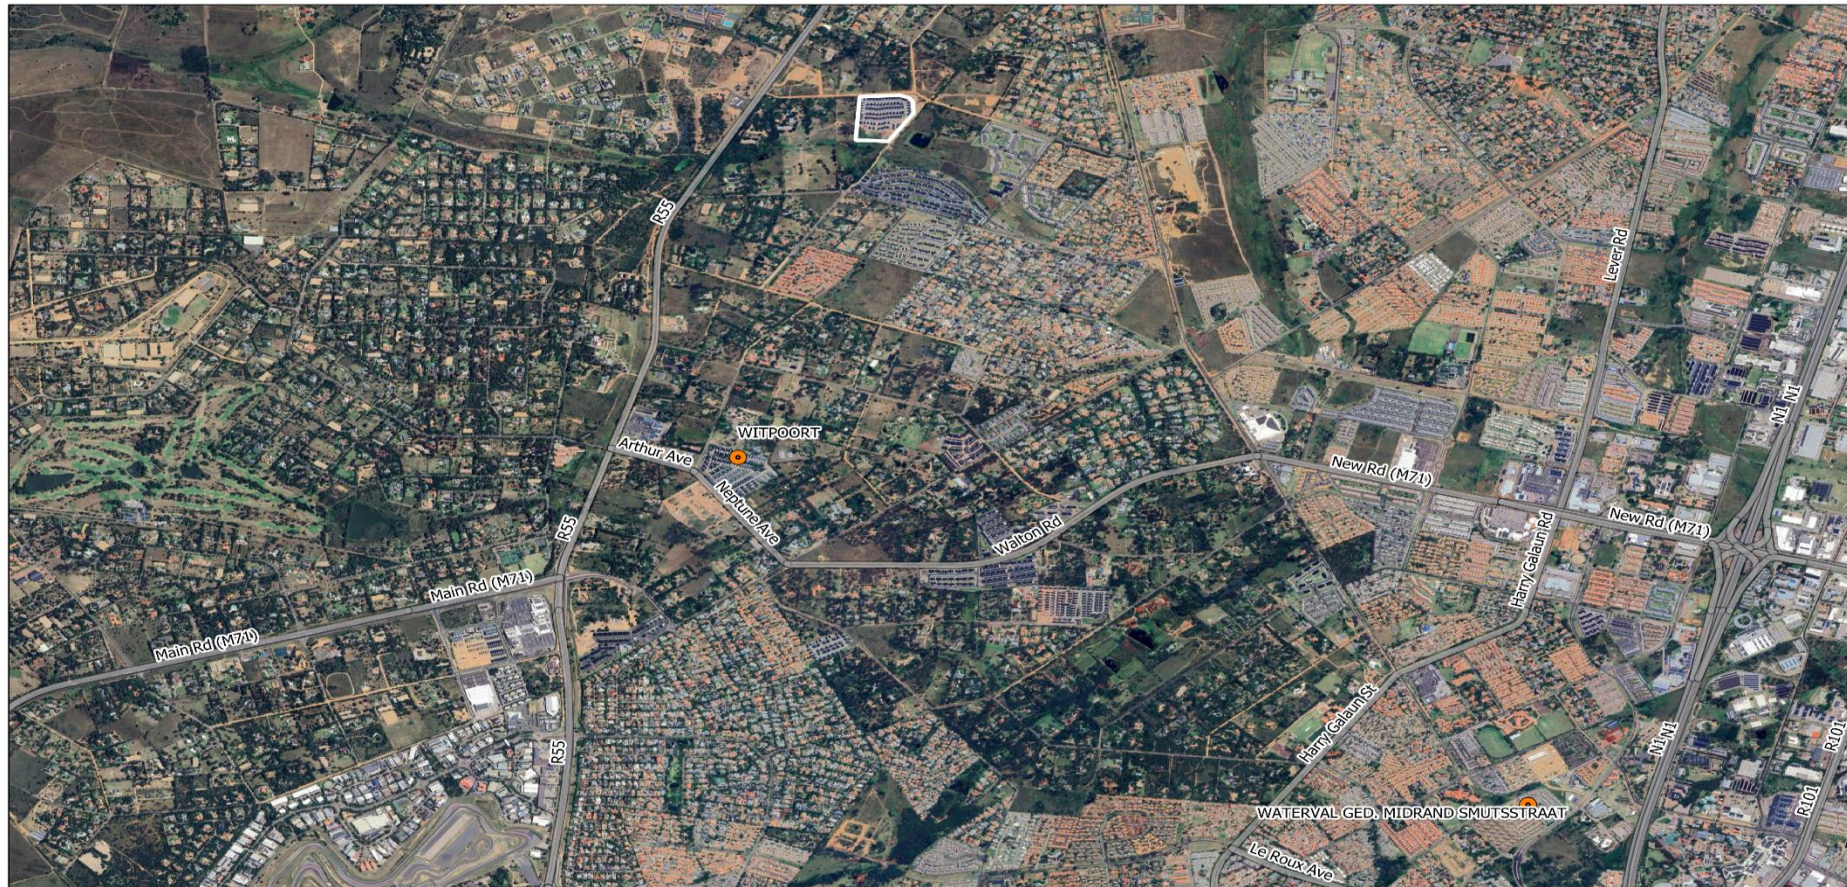
Data collected from the NGA database can be outdated and some borehole attributes could have changed over the years, or the borehole has since been destroyed. It is important to note that this information only serves as a baseline to understand the groundwater regime. The table below (Table 3-1) summarizes the NGA data obtained within a 5km radius of the site. Figure 3-1 shows the locations of the boreholes with groundwater levels obtained from the NGA data.
